PHASE B REPORT

MATERIALS PROCESSING IN SPACE M512

CONTRACT NAS 8-28725

July 15, 1973

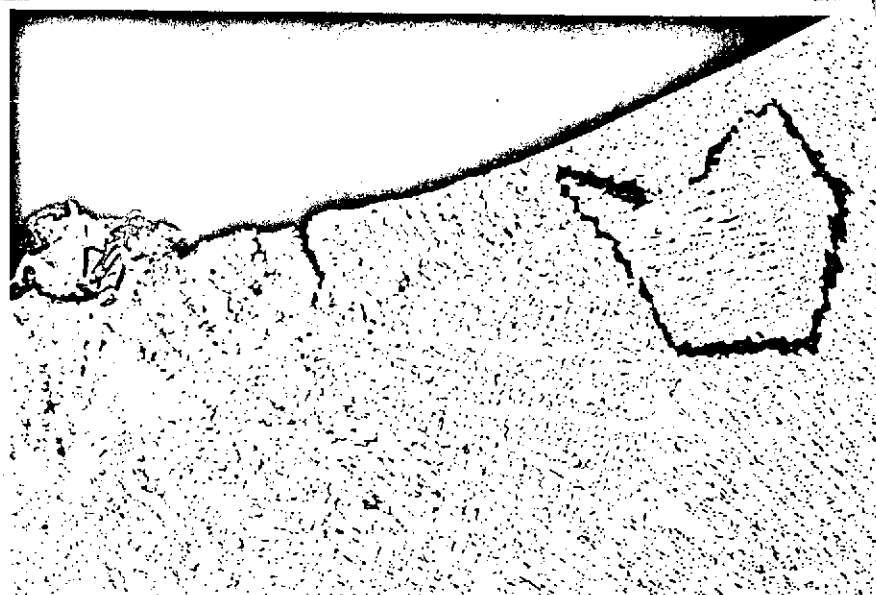
FIGURE A-22. CRACKS NEAR TOP OF DWELL REGION- H-1

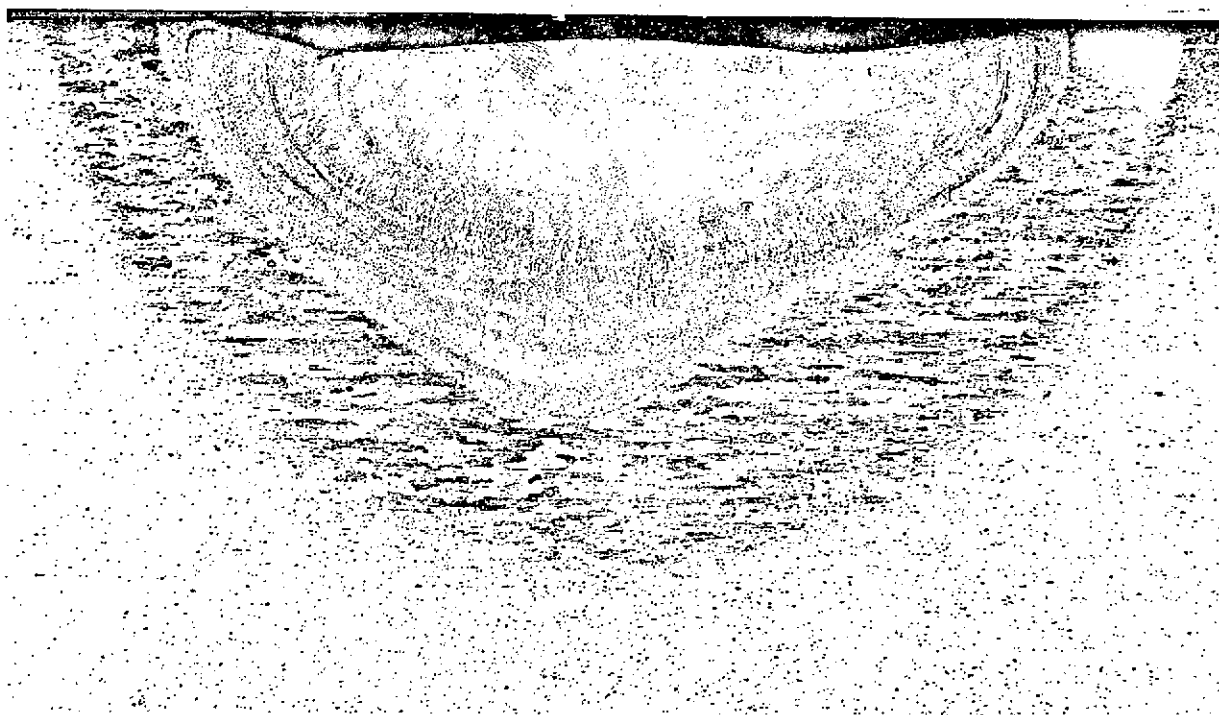
FIGURE A-27. SECTION THROUGH PARTIAL PENETRATION
REGION - S/N-124

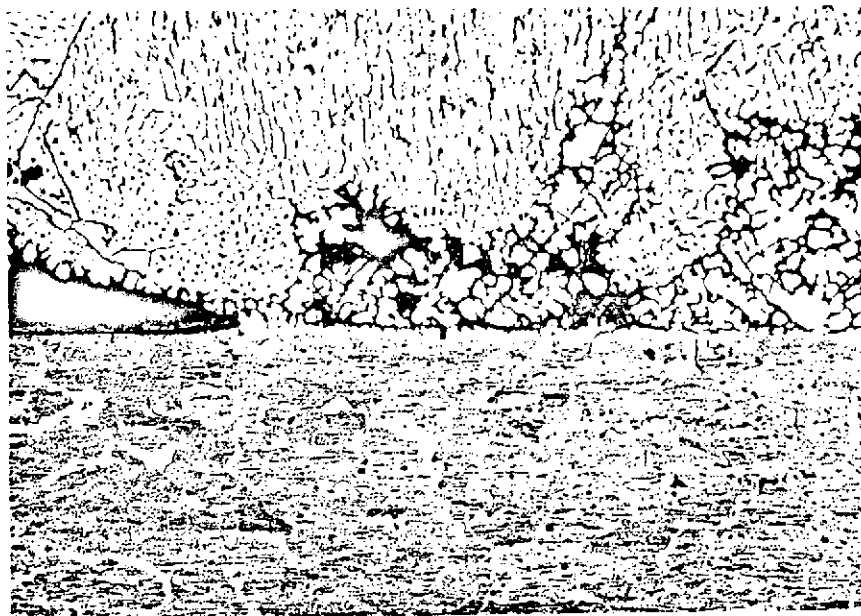
FIGURE A-32. STRUCTURES IN DWELL REGION
S/N-124

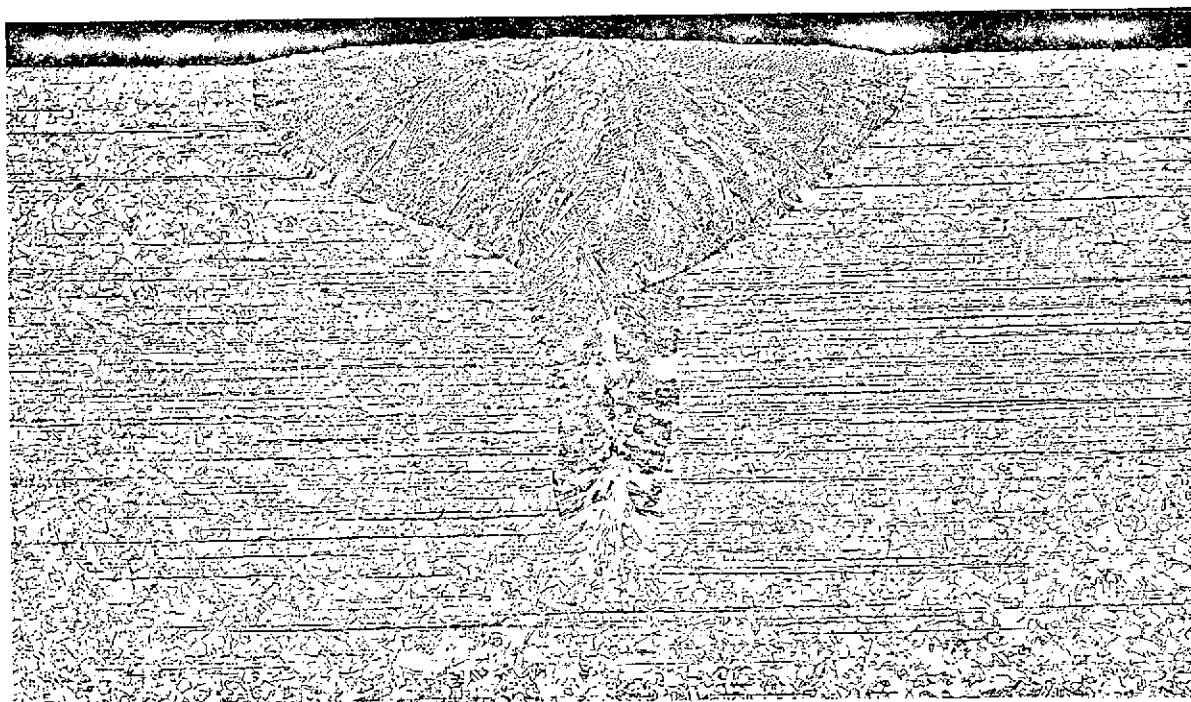
FIGURE A-48. SECTION THROUGH PARTIAL PENETRATION
REGION S/N 104

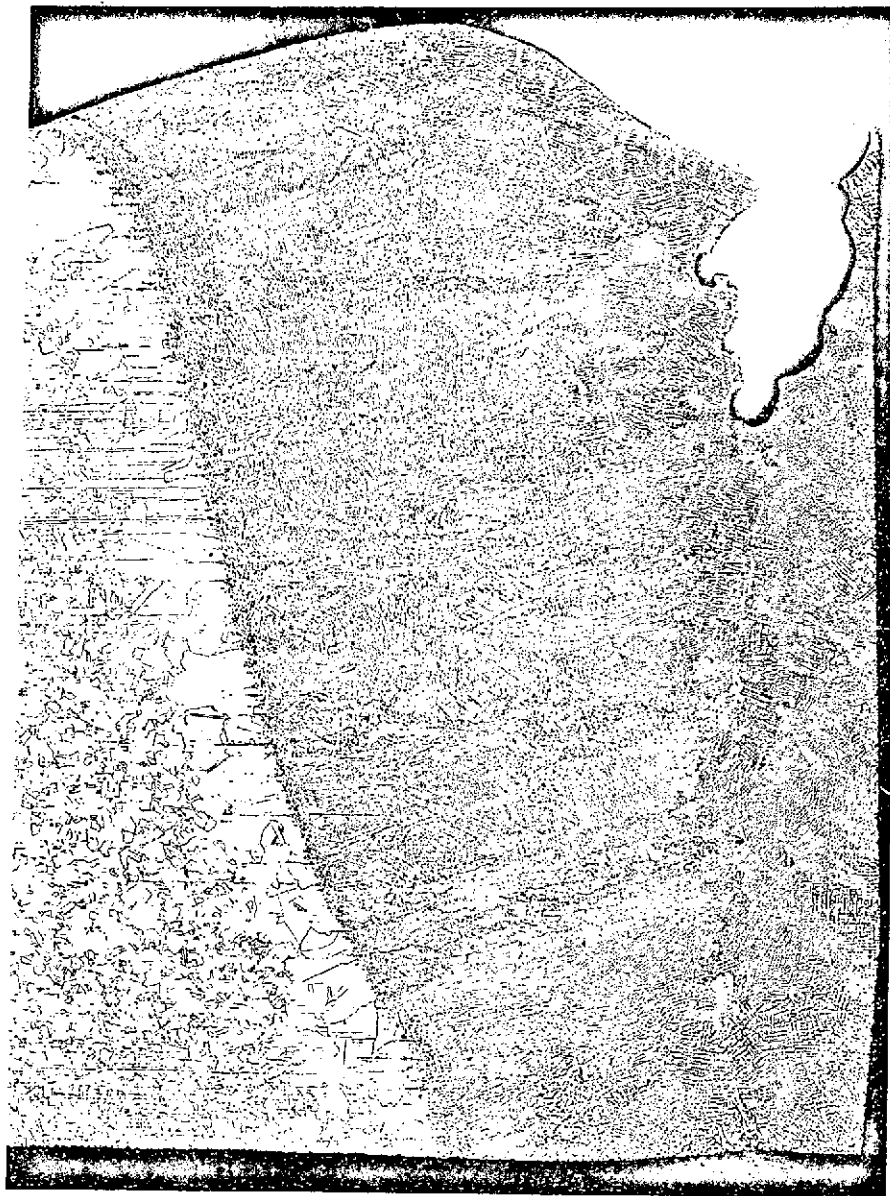
a. Chord Section

FIGURE A-50. SECTIONS THROUGH DWELL REGION, S/N 104

b. Top Edge Fusion Line

c. Typical Weld Microstructure

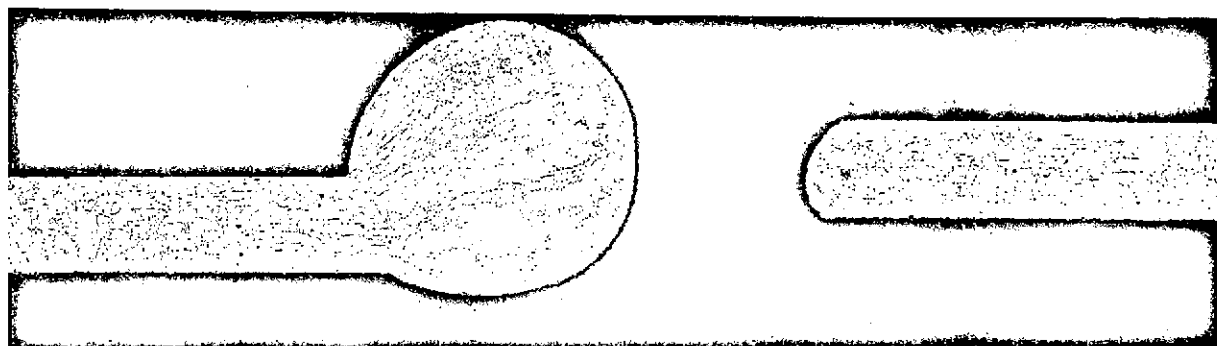
FIGURE A-53. SECTION THROUGH CUT REGION
S/N 107

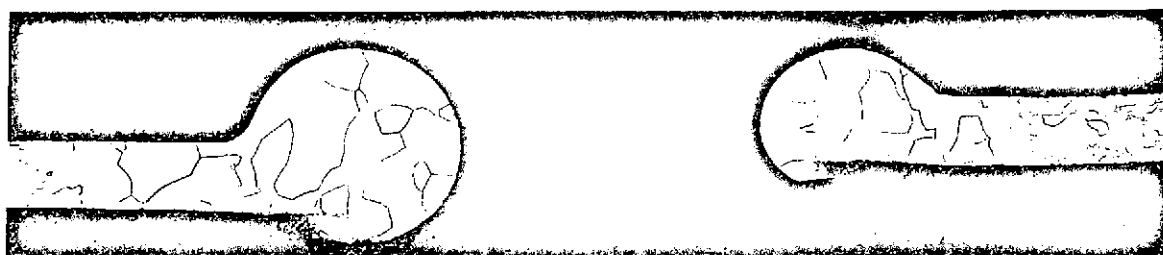
FIGURE A-57. SECTION THROUGH CUT REGION S/N 143

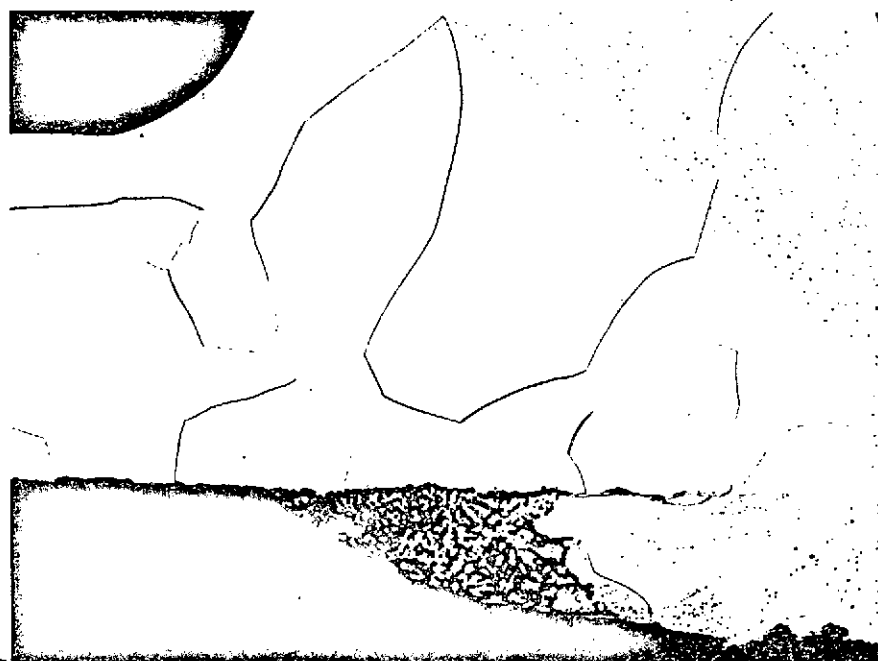
FIGURE A-58. BOTTOM SURFACE OF OUTSIDE CUT EDGE S/N 143
